TECHNICAL REPORT REMR CO-3

CASE HISTORIES OF CORPS BREAKWATER
AND JETTY STRUCTURES

Report 1
SOUTH PACIFIC DIVISION

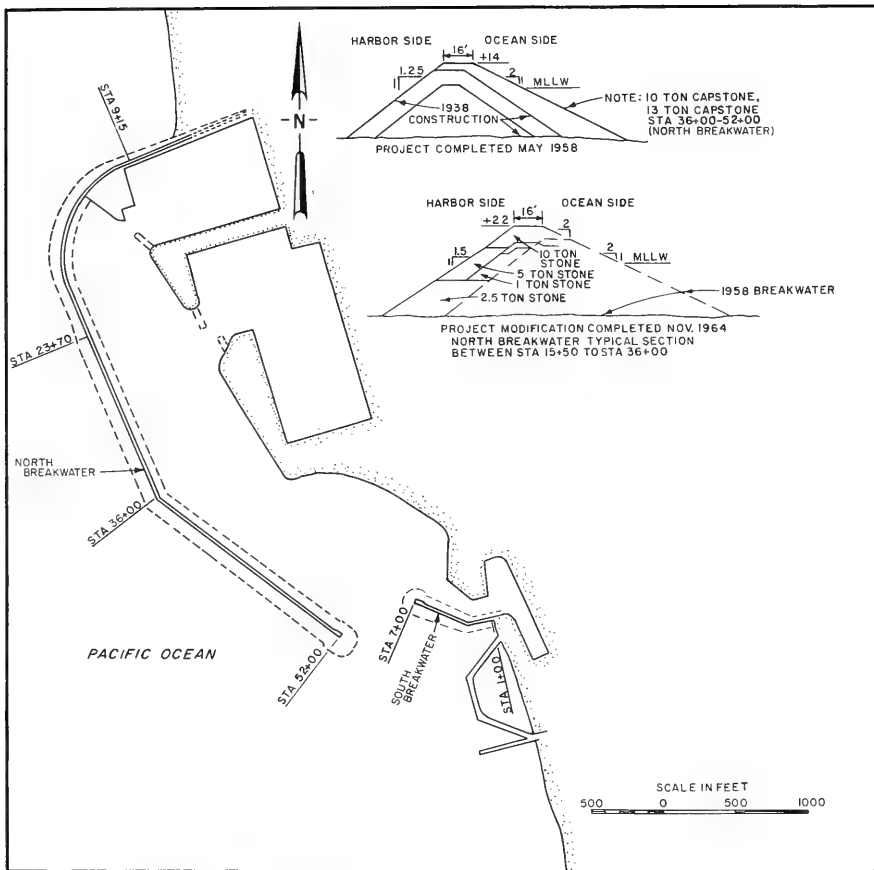
Figure 28. Redondo Beach King Harbor, California

<u>Date(s)</u>	<u>Construction and Rehabilitation History</u>
1938	Construction of a 4,285-ft-long permeable, rubble-mound breakwater (Figure 28) was completed.
1950	The breakwater became a Federal project, and improvements were authorized.
1958	Ten-ton capstones were placed on the ocean side of the breakwater on a 1V:2H slope, and the crest was raised to +14 ft mllw and increased to 16 ft in width. Thirteen-ton capstones were used on the breakwater between sta 36+00 and 52+00. A 600-ft-long south breakwater with a crest el of +14 ft was constructed. The structure has a 16-ft crest width, and side slopes were 1V:2H on the sea side and 1V:1.5H on the harbor side.
1960	Minor repairs to the north breakwater (from a storm in 1959) were completed.
1963	Storms demonstrated the inadequacy of the north breakwater for protecting small craft within the Harbor. While doing only minor damage to the breakwater, damage to small boats and Harbor facilities amounted to \$431,000.

1964	The north breakwater (between sta 15+50 and 36+00) was modified. The structure crest el was raised to +22 ft mllw at this location. Stones, ranging from 2.5 to 10 tons, were placed on the harbor side of the breakwater on a slope of 1V:1.5H (Figure 28).
1978- 1980	Storms of 1978 and 1980 resulted in damage to the north breakwater in nine areas with major voids occurring at sta 16+00 and 22+00.
1982	As a result of the damages in 1978 and 1980, the north breakwater was repaired at a cost of \$304,000.
1983	Storms resulted in significant damage at several locations along the north breakwater. The most significant was a breach 70 ft long, just south of the curved portion. Repair work was completed, and approximately 5,300 tons of new capstone and 1,700 tons of corestone were utilized. At seven additional locations, about 4,000 tons of capstone were replaced. The repair work cost approximately \$400,000.

1986	The breakwaters presently are in satisfactory condition.

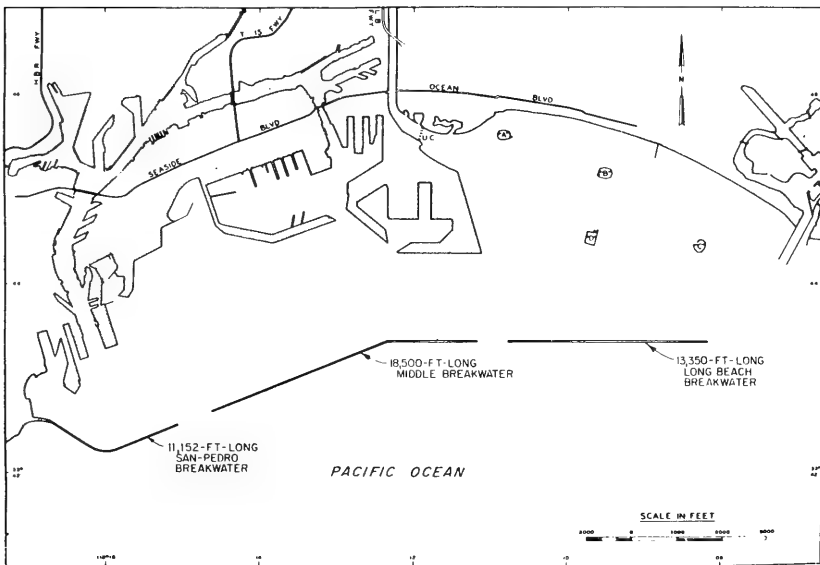
Figure 29. Los Angeles and Long Beach Harbors, California

Date(s)	Construction and Rehabilitation History
1898- 1910	Construction of the 11,152-ft-long San Pedro Breakwater occurred at the site (Figure 29). The harbor side of the structure was built with 1V:1.2H side slopes, while the ocean side consisted of 1V:1.2H slopes from the bottom up to an el of -12 ft mllw. At this point the slope changed to 1V:3H to an el of 0.0 ft mllw. The rubble-mound portion of the structure (Figure 30) was 47 ft wide at el 0.0 ft mllw. Granite blocks (up to 20 ton) were laid in courses to an el of +14 ft with a crest width of 20 ft. The rubble-mound portion of the structure was constructed with 8- to 10-ton stone and was permeable. Other structures, which are now incorporated into the inner harbor works, were constructed as early as 1871.
1930- 1938	Construction of the 18,500-ft-long rubble-mound middle breakwater (Figure 29) was in progress. The breakwater had a 16-ft crest width at el +14 ft mllw. Side slopes on the ocean side were 1V:2H and on the harbor side ranged from 1V:1.25H to 1V:1.5H (Figure 30). An impermeable core was installed from the bottom (approximately -50 ft mllw) to el -26 ft mllw.

1942- 1960	Construction of the 13,350-ft-long rubble-mound Long Beach Breakwater (Figure 29) occurred during this period. With the exception of the breakwater core el (Figure 30) the cross section of this structure was similar to that of the middle breakwater.
1947	Repairs to the middle breakwater were accomplished for a cost of \$786,700.
1983	Winter storms resulted in extensive damage to the San Pedro Breakwater. The structure was breached in an area immediately seaward of the curved portion of the breakwater. Model tests were conducted after the damage (Carver 1984, Baumgartner, et al. 1986), and restoration of the San Pedro Breakwater was subsequently completed. Work consisted of the placement of approximately 25,000 tons of salvage stone and new angular stones ranging from 15 to 25 tons each. Where voids occurred on the crest after this stone placement, concrete was pumped into flexible temporary forms to complete the repair.

1986	The breakwaters presently are in good condition.

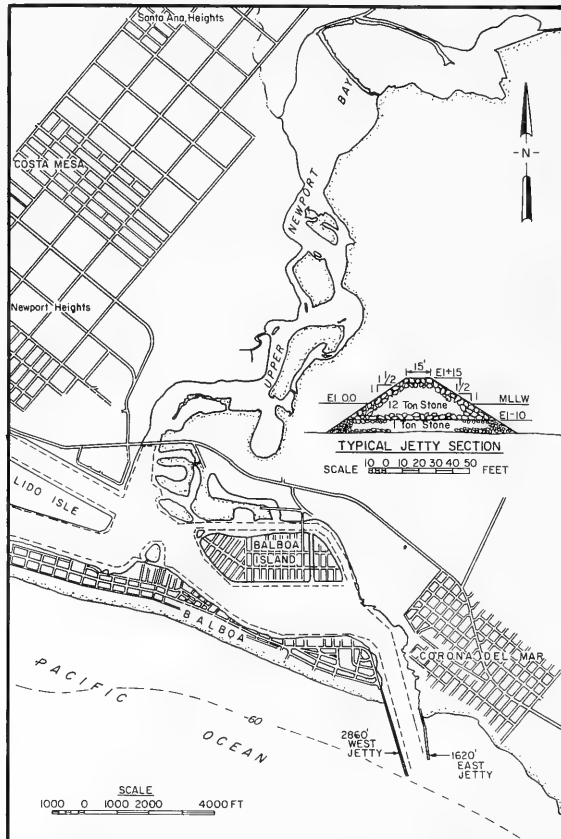
Figure 31. Newport Bay Harbor, California

<u>Date(s)</u>	<u>Construction and Rehabilitation History</u>
1934	Construction of two rubble-mound jetties at the site (Figure 31) was completed. The west and east jetties were 2,860 ft long and 1,620 ft long, respectively. The el of the structures was +15 ft mllw, and the crest width was 15 ft. Side slopes of 1V:1.5H on both ocean and harbor sides were used.
1986	Throughout the years, local interests have provided minor maintenance to the jetties, the extent of which is unknown. The jetties presently are in satisfactory condition.

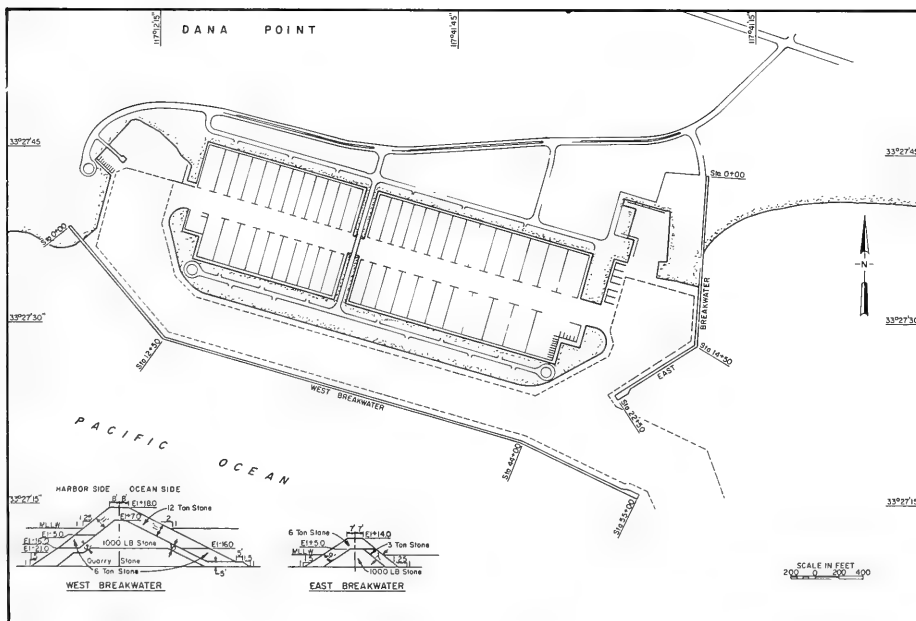
Figure 32. Dana Point Harbor, California

Date(s)	Construction and Rehabilitation History
1968	Construction of two rubble-mound breakwaters at the site (Figure 32) was completed. The west breakwater was 5,500 ft long with a 16-ft-wide crest at el of +18 ft mllw. The ocean side slope of the structure was 1V:2H, and the harbor side was 1V:1.25H. The east breakwater was 2,250 ft long with a 14-ft-wide crest width and a +14-ft el mllw. The ocean-side slope was 1V:1.5H, and the harbor-side slope was 1V:1.25H. Model tests were conducted for the project (Dai and Jackson 1966, Wilson 1966).
1983	Major storms resulted in approximately \$610,000 in damages to the breakwater.
1984	Restoration of the west breakwater in nine locations was completed. About 5,800 tons of capstone were used for this maintenance repair.
1986	The breakwaters are in satisfactory condition.

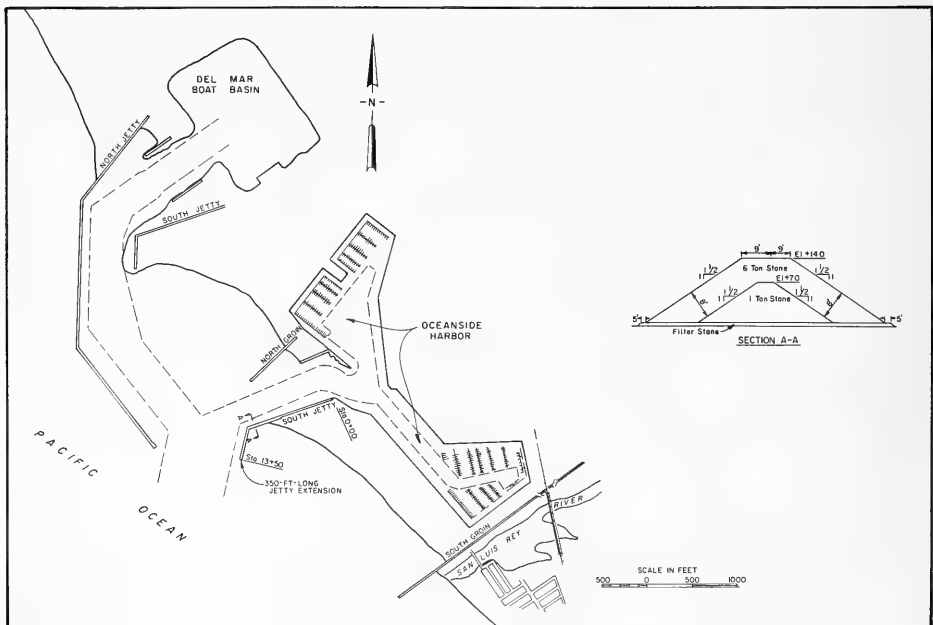
Figure 33. Oceanside Harbor, California

<u>Date(s)</u>	<u>Construction and Rehabilitation History</u>
1958	Construction of the Del Mar Boat Basin (formerly Camp Pendleton Harbor) was completed by the US Navy. The north and south jetties at the basin entrance also were constructed and are maintained by the Navy.
1961	The construction of a 1,000-ft-long rubble-mound south jetty at the entrance to Oceanside Harbor (south of Del Mar Boat Basin) was completed (Figure 33). The jetty had a crest el of +14 ft mllw and a width of 18 ft. Side slopes were 1V:1.5H.
1968	Construction of a 350-ft-long rubble-mound extension to the south jetty was completed. In addition, the existing jetty was sealed from sta 3+70 to 12+10 in an effort to minimize shoaling of the entrance channel. Grout holes were drilled through the armor stone and penetrated the core by 1 to 2 ft. Grout then was pumped in the holes under pressure to seal the structure.
1986	The jetty is in satisfactory condition.

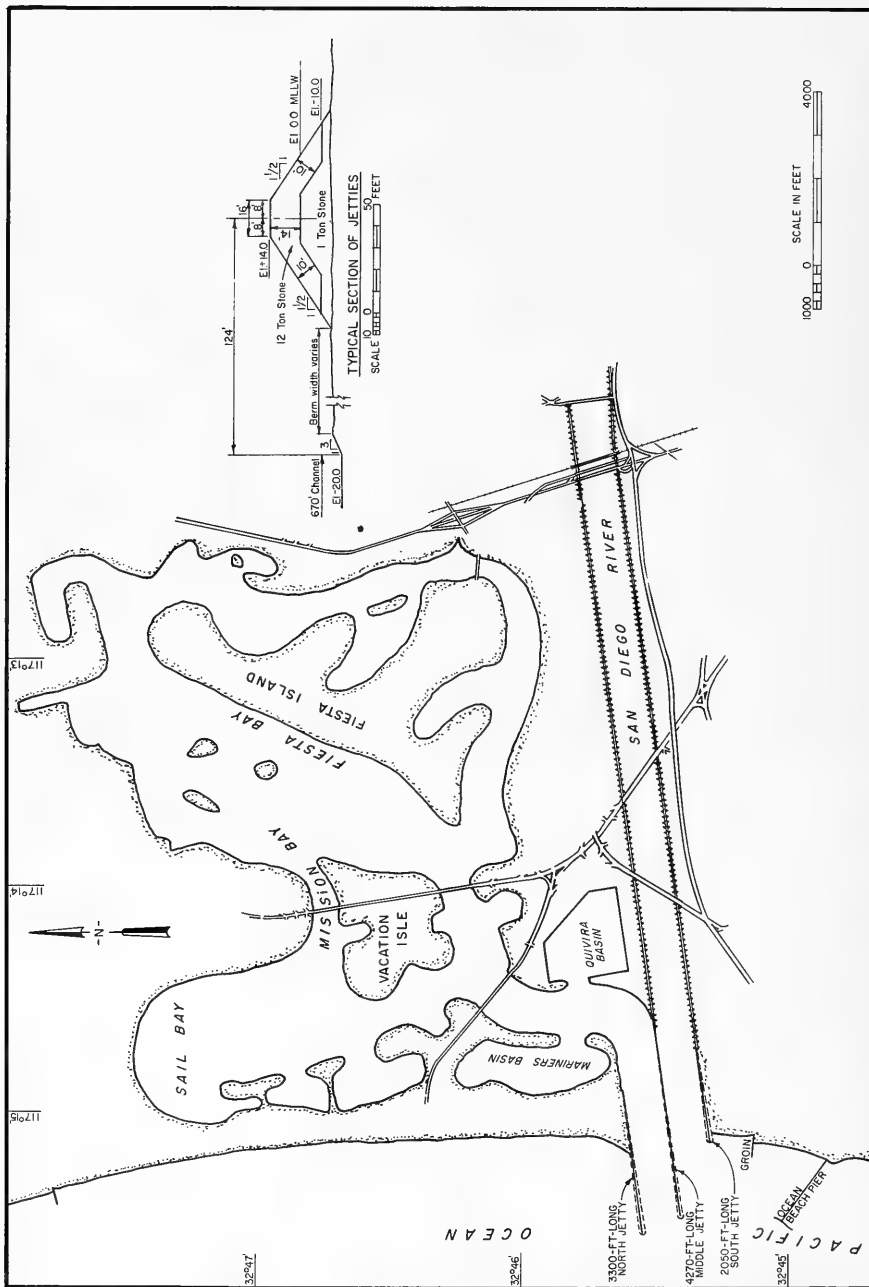
Figure 34. Mission Bay Harbor, California

<u>Date(s)</u>	<u>Construction and Rehabilitation History</u>
1949	Construction of three rubble-mound jetties at the site (Figure 34) was completed. These structures included a 3,300-ft-long north jetty, a 4,270-ft-long middle jetty, and a 950-ft-long south jetty. Typically, the jetties were built with a 16-ft-wide crest at an el of +14 ft mllw with side slopes of 1V:1.5H.
1955	Sediment from the littoral zone was noted passing through the north jetty into the entrance channel. Sealing stones (3,000 tons) were placed on the seaward slope of the jetty. This measure retarded the movement of sand but did not entirely stop infiltration.
1959	Approximately 1,300 ft of the middle jetty and 1,000 ft of the north jetty were sealed with grout to prevent the movement of sediment through the structures. The original core stone of the jetties was constructed at el 0.0 ft mllw. The intruded grout barrier was installed to el +6 ft mllw. The cost of this work was \$78,900.

1970	A 1,100-ft-long extension and sealing of the south jetty were completed. Jetty sealing was accomplished by installing a 3-ft layer of sealing stone in the littoral zone. The head of the middle jetty also was repaired in that the cover stone (12-ton) at the head of the jetty was restored. Total cost of the work was about \$566,000.
1986	The existing jetties currently are in satisfactory condition. Design has been completed for an offshore breakwater located seaward of the north and middle jetties that will provide additional wave protection for Mission Bay Harbor. The proposed offshore breakwater has been model tested (Curren 1983, Markle 1983, Bottin and Acuff 1985) but not yet constructed in the prototype.

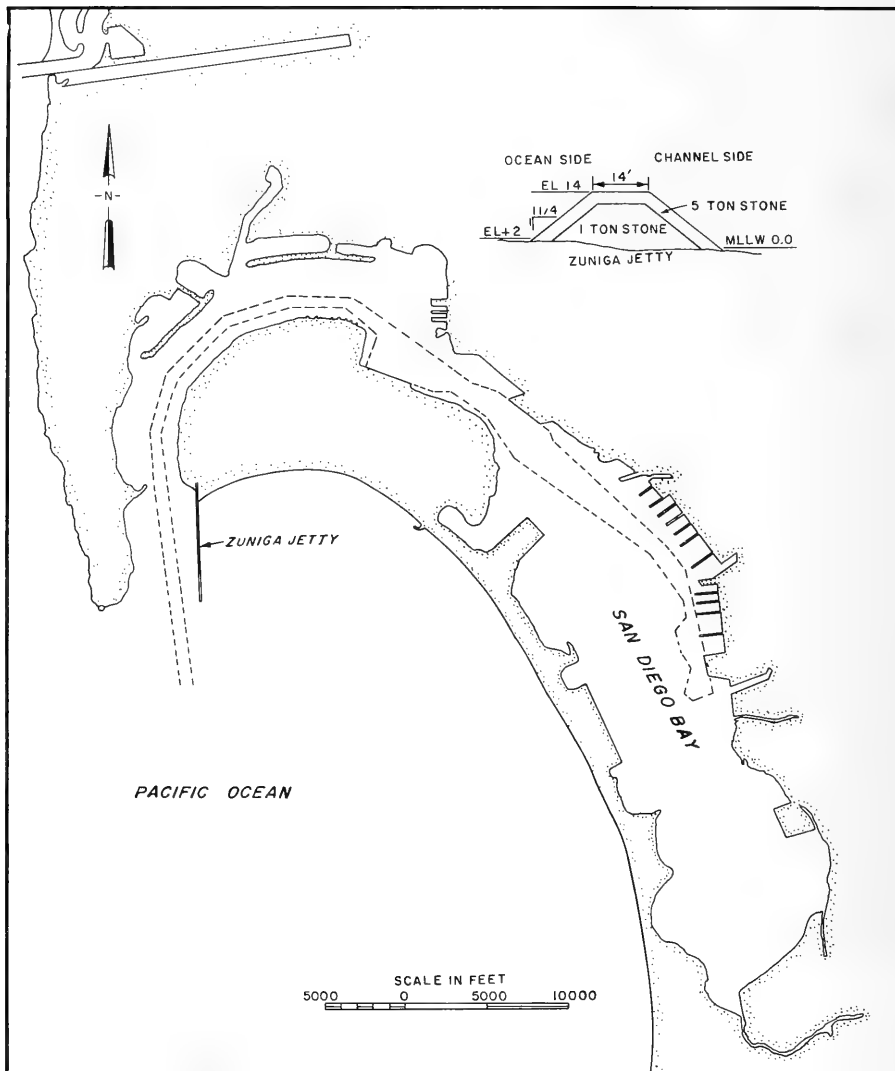
Figure 35. San Diego Harbor, California

<u>Date(s)</u>	<u>Construction and Rehabilitation History</u>
1894- 1902	Construction of a 7,500-ft-long rubble-mound jetty (Zuniga Jetty) was completed (Figure 35) during this time frame. The design height of the jetty was +14 ft mllw with a 14-ft-wide crest. Side slopes were 1V:1.25H. It is indicated, however, that the jetty was not constructed to the full design height.
1942	Rehabilitation work was performed by the US Navy from the shoreward end to a point about 1,400 ft seaward.
1943- 1969	Settlement and flattening of the slopes occurred, particularly in the outermost third of the jetty. As a result, parts of the jetty were awash or submerged at most tide stages, creating hazards to navigation.
1970	Maintenance repair of the jetty was accomplished for a cost of approximately \$127,000. This work consisted of the construction of platforms on the jetty for navigation lights which were installed by the US Coast Guard to alleviate hazards to navigation.

1984	Maintenance repair of the jetty was completed, the extent of which is unknown.
1986	Even though the jetty was not constructed to full design height, it functions satisfactorily as a training wall which concentrates tidal flows and keeps the entrance channel scoured to project depth.
